# ANGIOINO CASTLE APULIA

PRODUCTS FROM THE MAPE-ANTIQUE LINE EMPLOYED  
TO RESTORE AND PRESERVE A NATIONAL MONUMENT  
IN THE SALENTO AREA IN SOUTHERN ITALY

**Castello Angioino**, Copertino (Lecce, Italy)

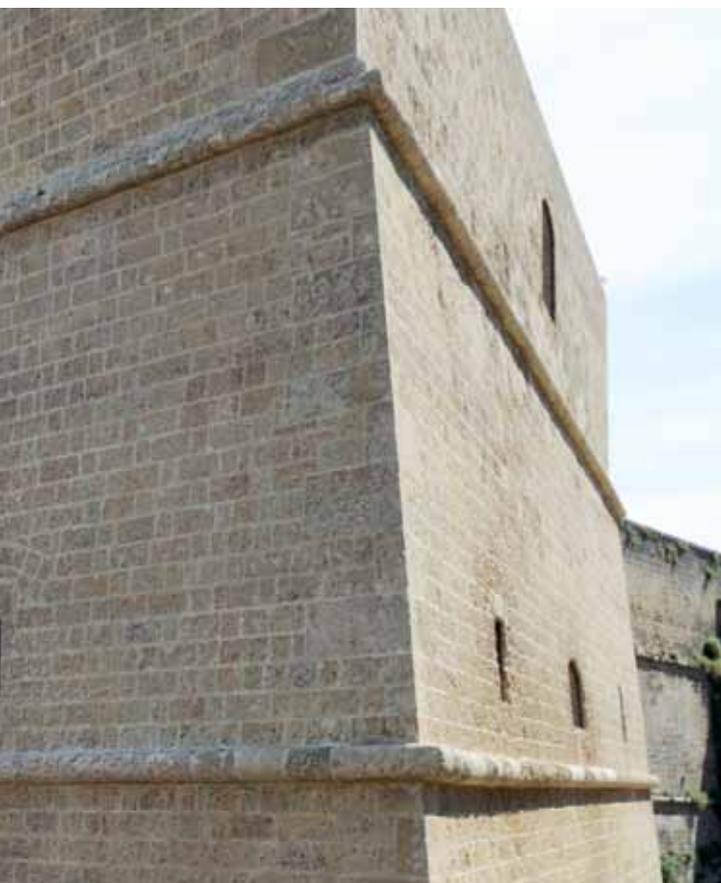
**FACING PAGE AND ABOVE.** Angioino Castle in Copertino (Lecce, Italy) upon completion of the work. Mapei brand products were supplied to restore the walls.

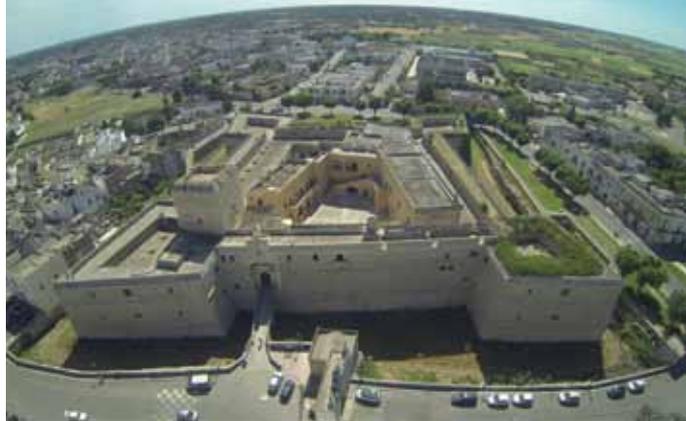
**ABOVE.** The castle before commencing work. Before starting the intervention, an in-depth study was carried out to analyse the problems with the walls and identify the most appropriate solutions.

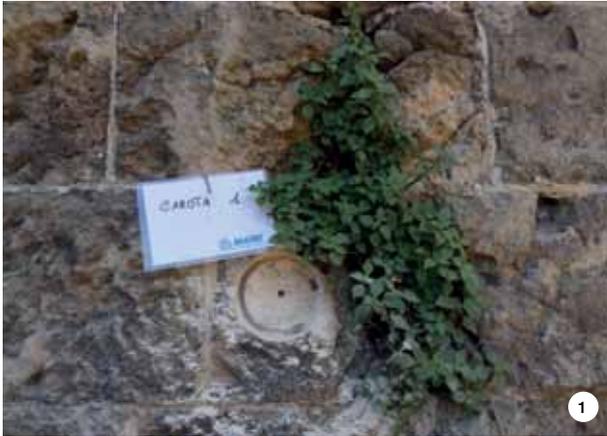
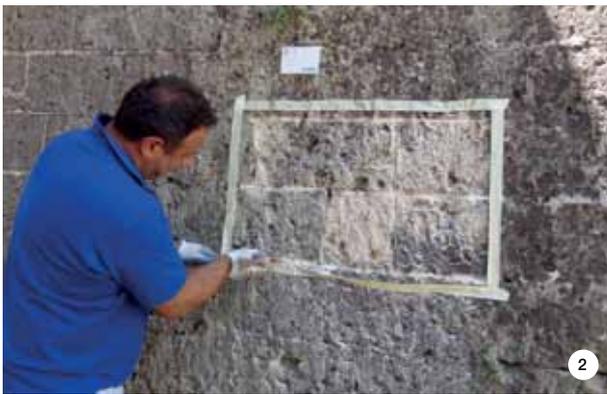
**PHOTOS 1 and 2.** A preliminary analysis was carried out to get a more in-depth understanding of the materials used to build the facing walls.

An in-depth study of the materials used specifically for the facing walls was carried out by the Mapei Laboratories, who performed a preliminary testing campaign in order to characterise the chemical and physical properties of the stone and mortar used to build the facing walls, identify the cause of the damage and choose the most appropriate products.

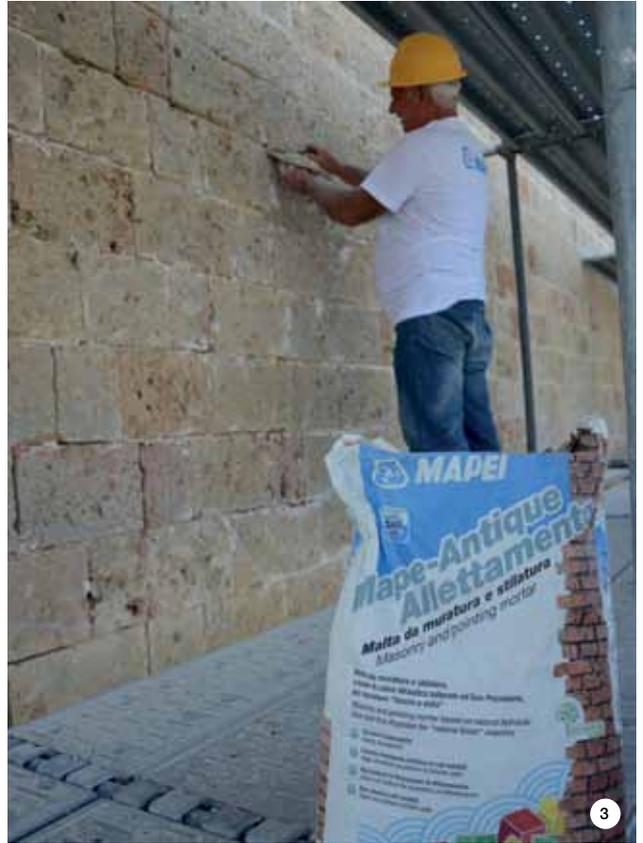
**PHOTO 3.** MAPE-ANTIQUÉ ALLETTAMENTO was used for "patching" and "cladding" and to repoint the exposed walls.

Restoration of the walls using the "patching" and "cladding" techniques was required in the more badly damaged areas of the facing wall, where blocks were either missing or cracked and where the joints between different portions of the same wall had been damaged. All these operations were carried out using MAPE-ANTIQUÉ ALLETTAMENTO, a ready-mixed, cement-free, powdered building mortar made from natural hydraulic lime, Eco-Pozzolan, natural sand, special additives and microfibers according to a formula developed in the Mapei research laboratories. The joints between the blocks of tuff were also pointed with MAPE-ANTIQUÉ ALLETTAMENTO.

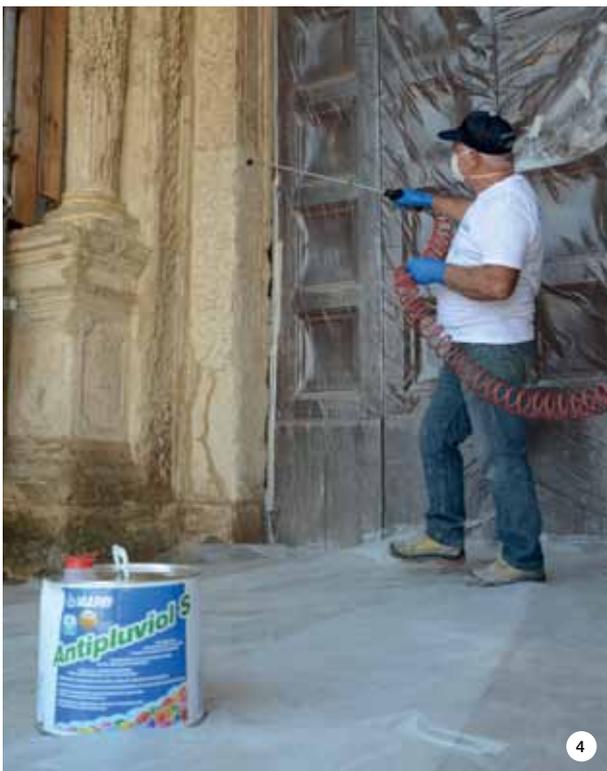
**PHOTO 4.** In the final phase of the work, the facing walls were protected with ANTIPLUVIOL S, a transparent, water-repellent, silane and siloxane-based impregnator.

In order to provide adequate protection to the facing walls and ensure the durability of the restoration work, the final and decisive phase of the intervention was to treat the exposed stones with the water-repelling product ANTIPLUVIOL S, a transparent, water-repellent finish made from silanes and siloxanes in solvent, which penetrates deep down into the substrate and reacts with the natural moisture inside walls to form a hydrophobic layer that repels water.

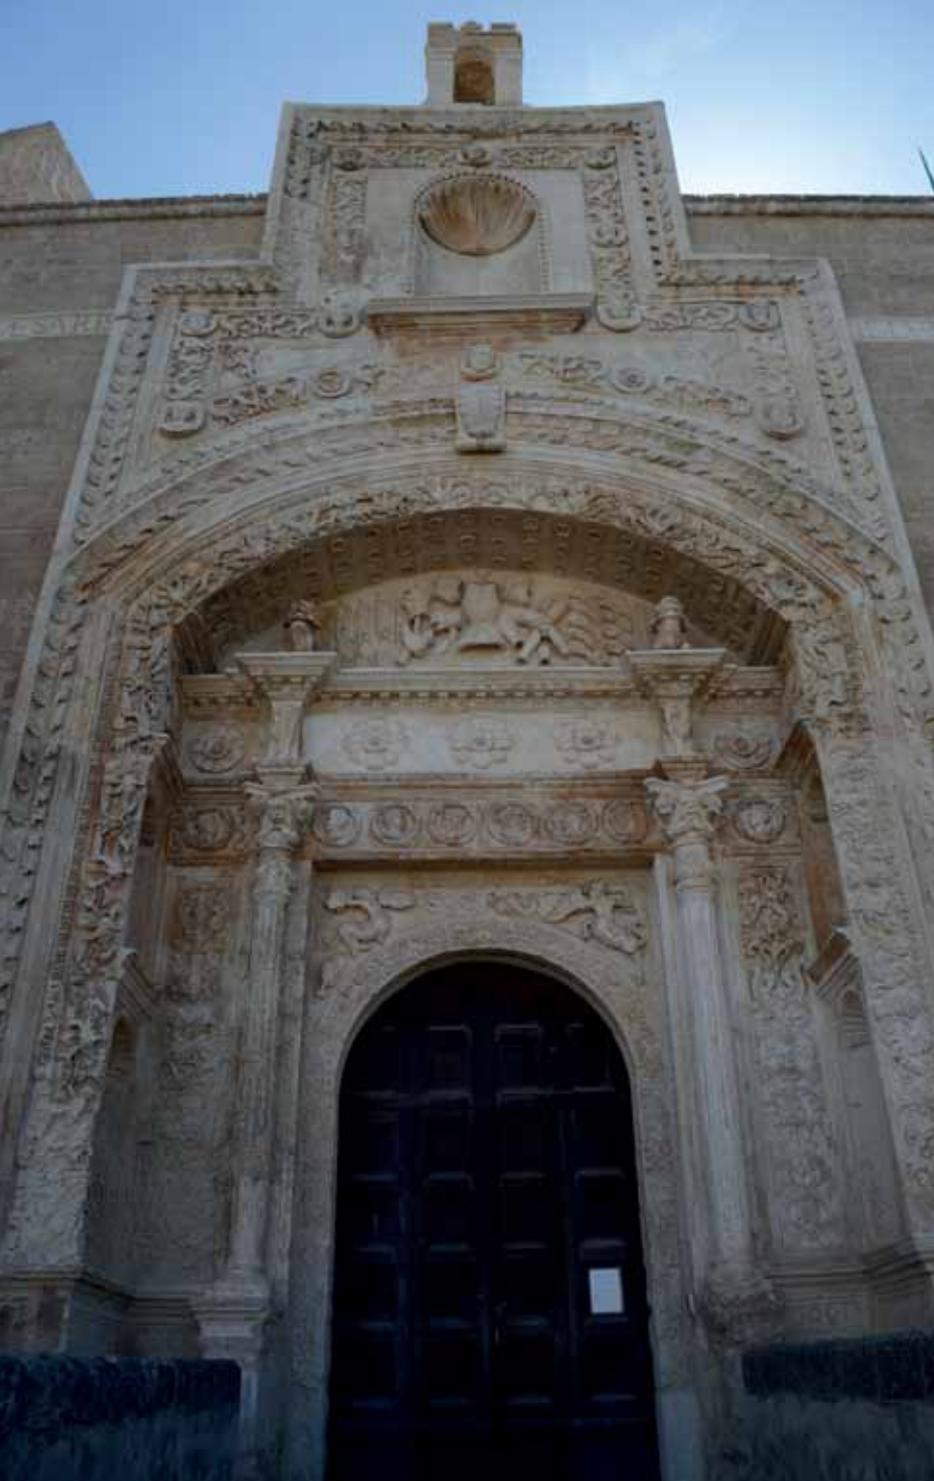
**TO THE LEFT.** The lavish portal to the castle: its decorative surrounds are carved from local limestone.
