Using the Mape-Antique and Silexcolor ranges, Mapei ensured protection and decoration to the walls of an art atelier in Budapest.

## Colour and Protection FOR THE NOUVEAU ATELIER

**Atelier House,** Budapest (Hungary)

**Work:** renovation of the façades

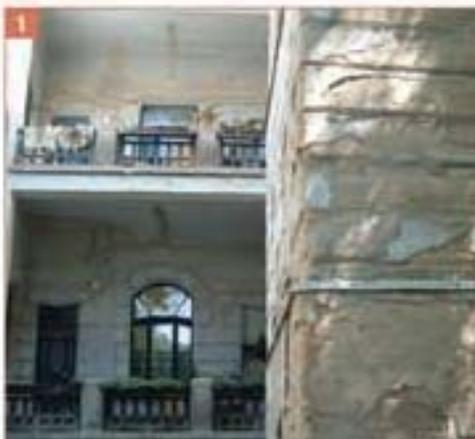
#### Photo 1.

The building, which dates back to the early 20<sup>th</sup> century, had a badly damaged façade and walls, due mainly to rising damp.

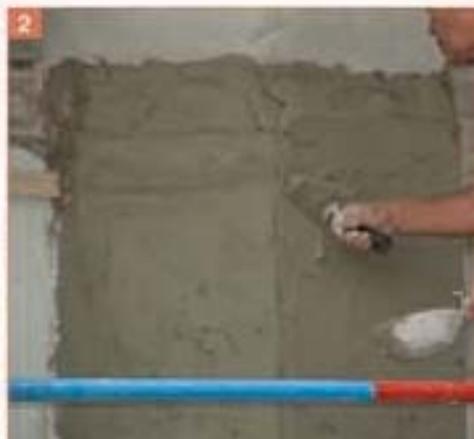
#### Photo 2.

During renovation works, Mape-Antique MC dehumidifying mortar was applied on the surface.

MAPE-ANTIQUÉ RINZAFFO\* is also particularly useful for improving the adhesive properties of micro-porous mortars. A dehumidifying layer of MAPE-ANTIQUÉ MC\*, a pre-packed dehumidifying mortar for repairing damp walls made of stone, brick and tuff, was then applied.

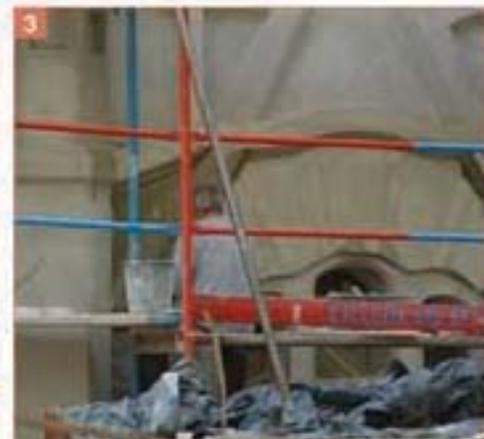
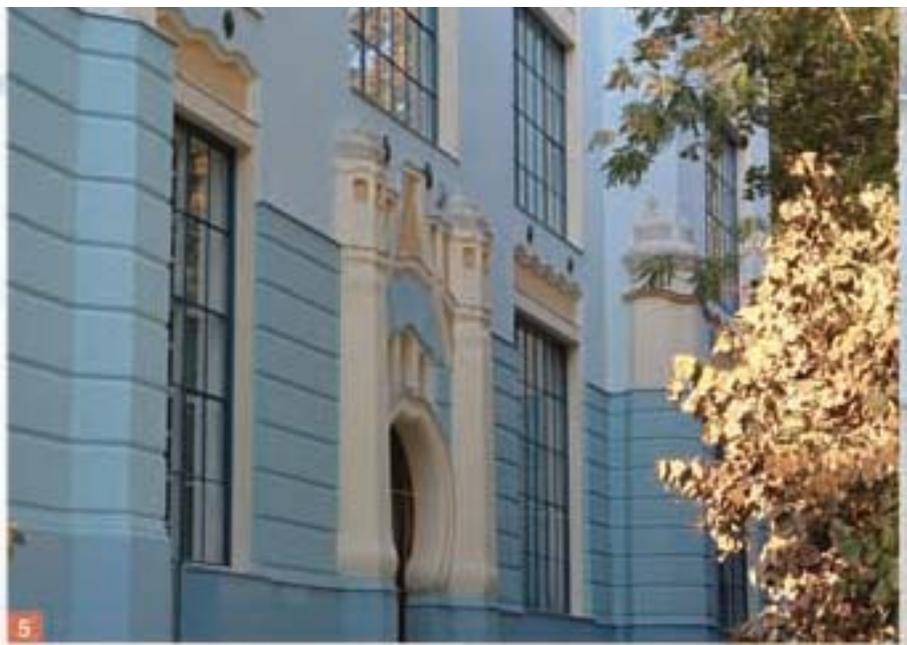
#### Photos 3 and 4.

The façade was given a colourful touch using Silexcolor Paint.

After completing the cycle of MAPE-ANTIQUÉ products, the original colours (light blue, yellow and white) were then restored to all the outside walls using products from the SILEXCOLOR range. These are silicate-based products for wall coatings guaranteeing high adhesion to the substrate, high transpirability, excellent resistance to chemical agents (i.e. acid rain, mold etc.) and a nice look of the final surface. Most notably, it was opted to use SILEXCOLOR PAINT\*, a product available in 34 colours and particularly suitable for porous vertical surfaces to which a protective but steam-permeable film is to be applied once it has dried. Before applying SILEXCOLOR PAINT\*, the walls were treated with a modified potassium silicate-based primer in water dispersion, SILEXCOLOR PRIMER\*, capable of helping the subsequent finishing coat to adhere more effectively.

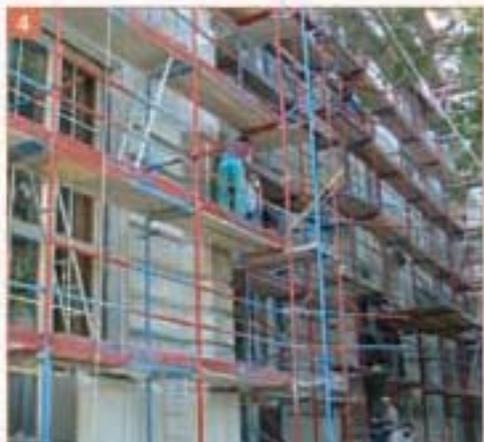
#### Photo 5.

The façade was brought back to its original colours.
